LAKE SHERWOOD DAM
ST. LOUIS COUNTY, MISSOURI
MO. 11017

PHASE I INSPECTION REPORT NATIONAL DAM SAFETY PROGRAM

Name of Dam: Lake Sherwood Dam, Missouri Inv. No. 11017
State Located: Missouri
County Located: St. Louis
Stream: Headwaters of the River des Peres
Date of Inspection: June 11, 1979

PHASE I INSPECTION REPORT
NATIONAL DAM SAFETY PROGRAM

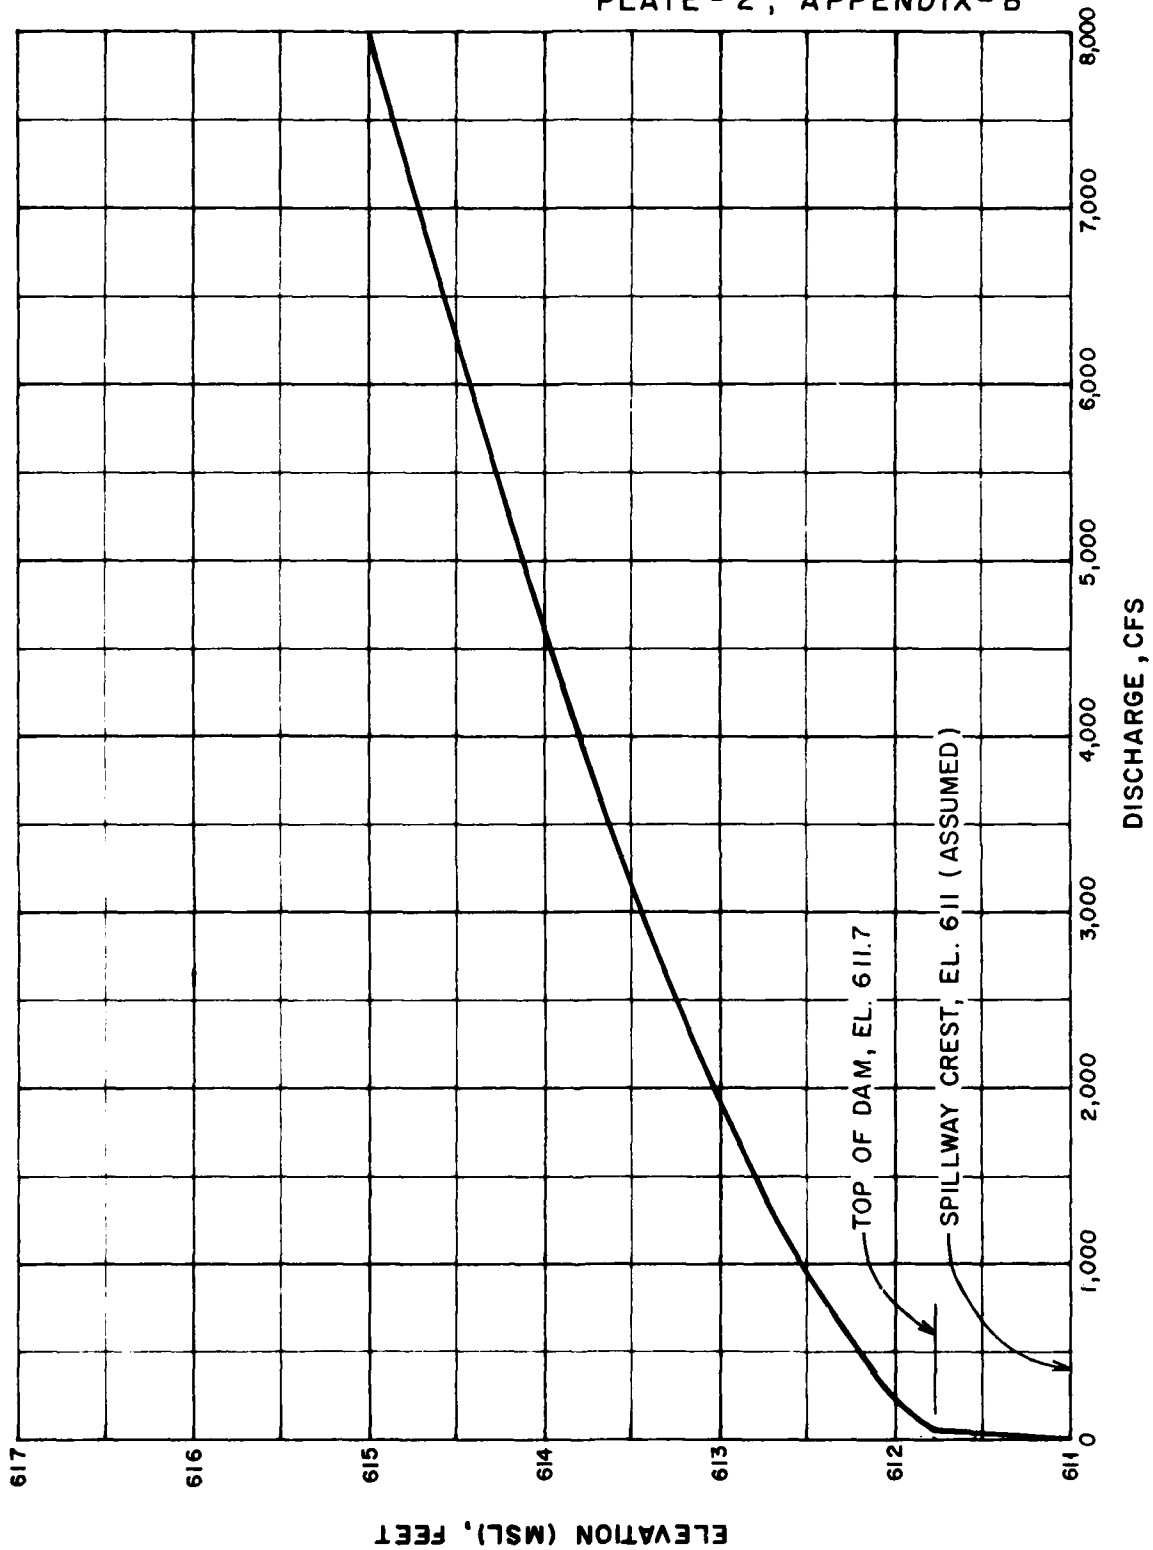
LAKE SHERWOOD DAM (MO. 11017)
SPILLWAY & OVERTOP RATING CURVE

The spillway capacity of Lake Sherwood Dam was found to be "Seriously Inadequate". The spillway/reservoir system will accommodate only 7 percent of the PMF without overtopping the dam. The spillway/reservoir system can not even accommodate the 10-year flood without overtopping the dam.

1. Spillway capacity and/or height of the dam should be increased to accommodate the PMF without overtopping the dam. The overtopping depth during the occurrence of the PMF, stated elsewhere in this report, is not the required or recommended increase in height of the dam.
2. Action should be taken to determine the cause or causes of the observed seepage (i.e. rodent holes, decayed roots, original buried pipes, foundation, etc.), and the seriousness of the situation. Properly positioned
